Matus / Meza House

Building Condition Assessment Report
July 2009

a project of the
Tucson Historic Preservation Foundation
for the
San Ignacio Yaqui Council

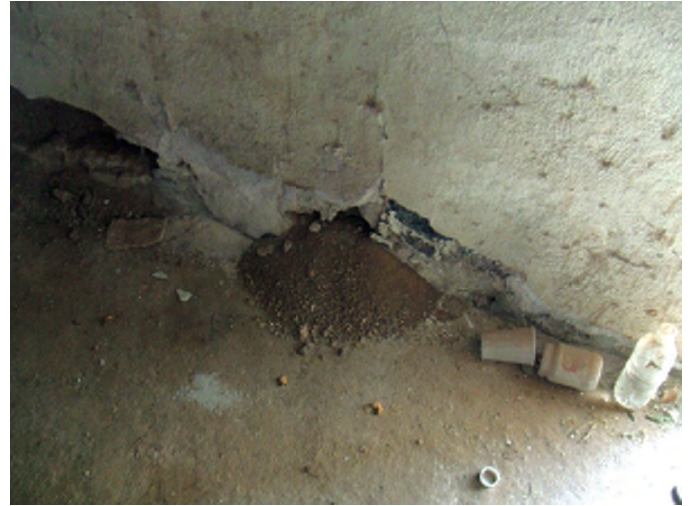
Walls suffer from several deficiencies. Most noticeable are the piles of eroded adobe visible at several of the walls where it appears that vermin and rodents have excavated through the walls. Because of the cement plaster finish, it is not clear if these damaged areas are compromising the structural integrity of the wall. Eliminating the source of the deterioration, the rodents and critters, would solve this problem and eliminate the likelihood of additional structural damage.

Deteriorated adobe at base of wall caused by burrowing vermin

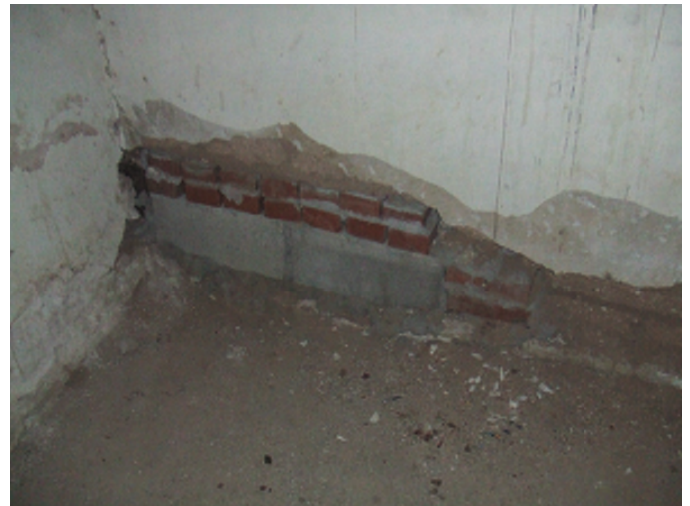
The corner fireplace is constructed of brick. Additionally, several other walls have areas of brick in-fill where adobe deterioration was repaired.

Infill masonry at the base of the eastern wall in the north-central room

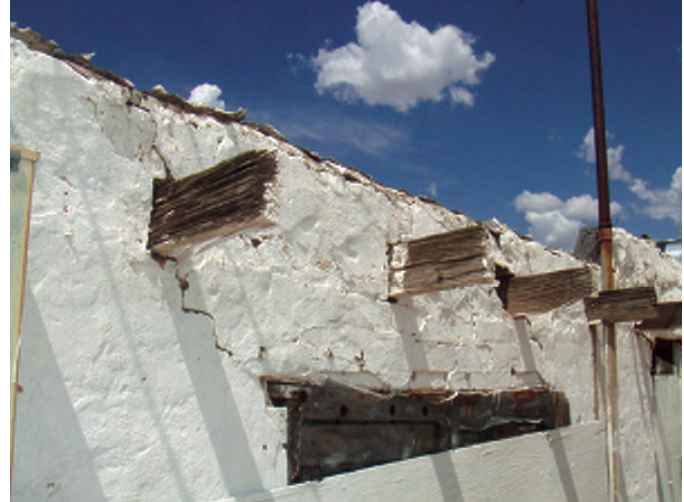
The building has two roof framing systems, one enclosing the original three room adobe core and the other framing in the two rooms at the south of the building. Overall, the roof and roof structure is in very poor condition. Serious structural problems, including rotted and split joists, are present. Many of these problems are created by the incompatible roof shapes “nested” together to create the overall form of the building. The three northern-most rooms are enclosed with a shallow gable roof, sloping to the north and the south. The southern addition to the three room core features a “reverse shed” slope that drains back towards the south slope of the gable form. The valley created by these two intersecting roof forms does not drain correctly and is the location where water has penetrated the roof framing and interior of the building. Portions of the roof where the two roofs come together could collapse if they are not further stabilized.

Roof framing at south wall. Note rotted joist ends.

The future use of the building will determine the extent of roof repairs required to make the building safe. If occupation of the building is desired, the entire roof and framing will need to be replaced. If a more modest use of the building is envisioned, such as an accessory shed for a community garden, the repairs required will be more modest. Stabilization and repair of roof framing is the most urgent and costly need for the building. Either scenario will require repairs costing between several thousand to over \$10,000.

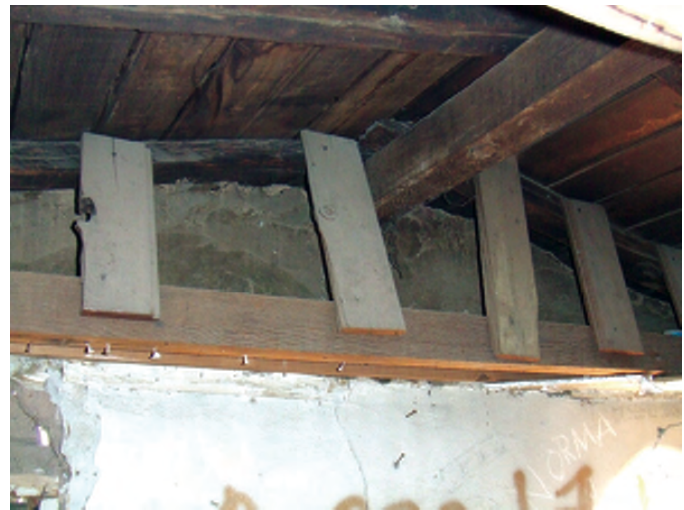
The northern gable form is created with a random assortment of framing members. Many of these members appear to have been structurally compromised by a fire, at an unknown date, within the structure. The framing consists of a 4 x 4 ridge beam (larger at the kitchen) that supports sloped 2x members at approximately 30- 38” on-center. The 2x members are supported at the north wall and the interior wall where the “reverse shed” is also supported. 2x4 ceiling members are attached to each joist at the end walls and also supported by 1x6 decking attached to the sloped rafter. Where the fire caused the joists to fail, additional 2x members have been added. 1x6 tongue and groove decking is present above the sloped rafters. The decking appears to be in good condition.

Site-built roof framing in northern rooms

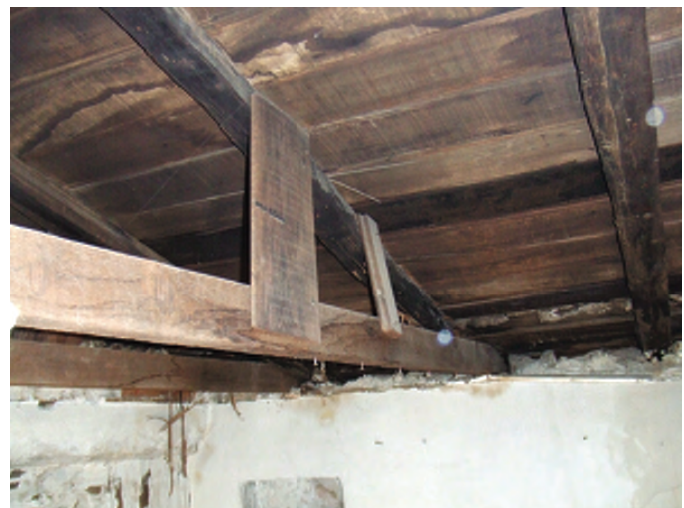
Typical roof framing in northern rooms.

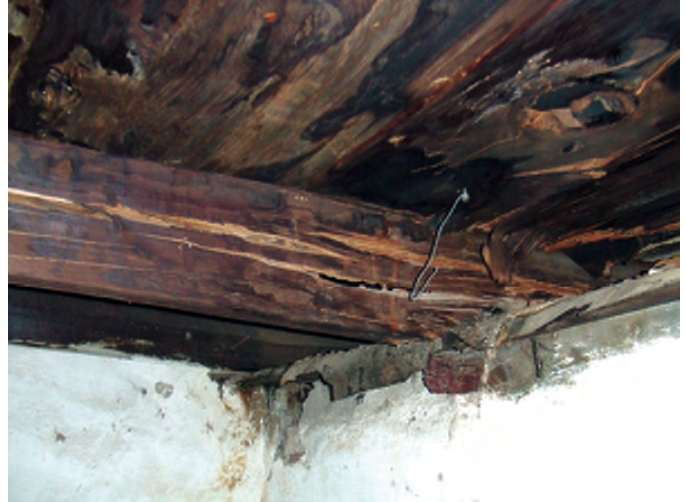
In addition, the roof and the electrical system are in need of attention. Because of the Ad Hoc style of modifications to this house, the structural integrity of the roof has been greatly compromised. The three northern-most rooms are enclosed with a shallow gable roof, sloping to the north and the south. The southern addition to the three room core features a "reverse shed" slope that drains back towards the south slope of the gable form. The valley created by these two intersecting roof forms does not drain correctly and is the location where water has penetrated the roof framing and interior of the building.

Split roof joist at SW at room in southwest corner. Notice severe water damage to roof decking caused by faulty roof design.

One joist in the western room has been split near the north supporting wall. This joist appears to be in danger of splitting and should be stabilized or replaced. 1x8 and 1x10 decking is above the joists.

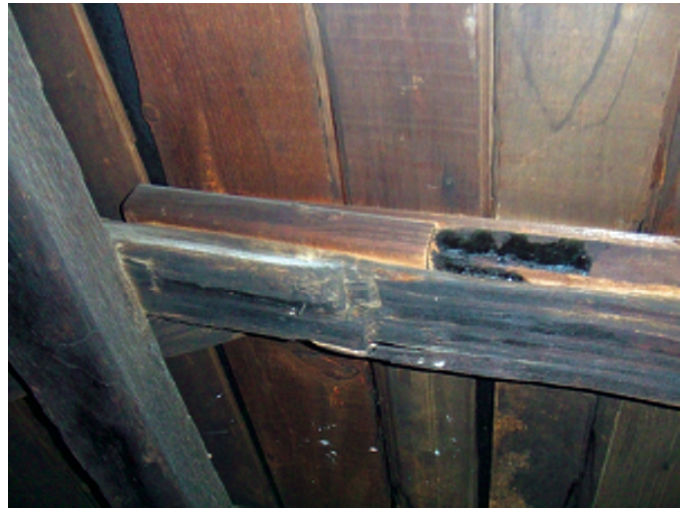
Charred roof framing with additional framing placed on top. This condition exists throughout the northern rooms

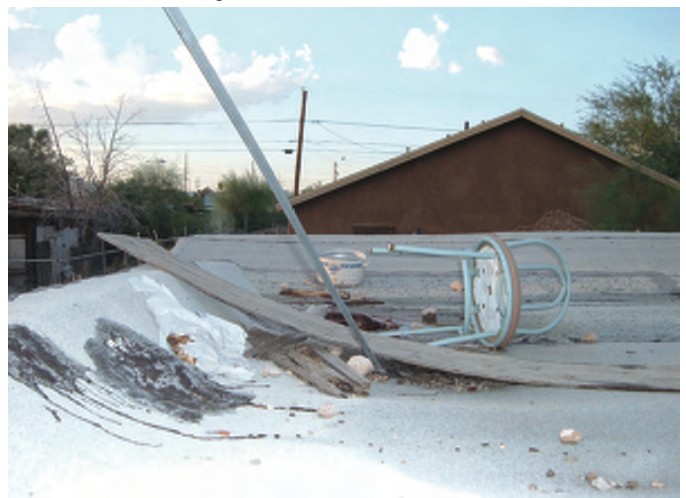
A temporary rolled asphalt roof appears to have been installed in the last 5 years. The asphalt is in fair condition. While there are problem areas with the roofing, it does appear to keep most of the water out of the building. The roof is littered with loose debris and household items, including a crock pot and chair. These items place additional strain on the roof and add to the difficulty of draining water from the roof. The items should be removed immediately and any holes should be patched to prevent additional infiltration of water.

Roof with loose debris

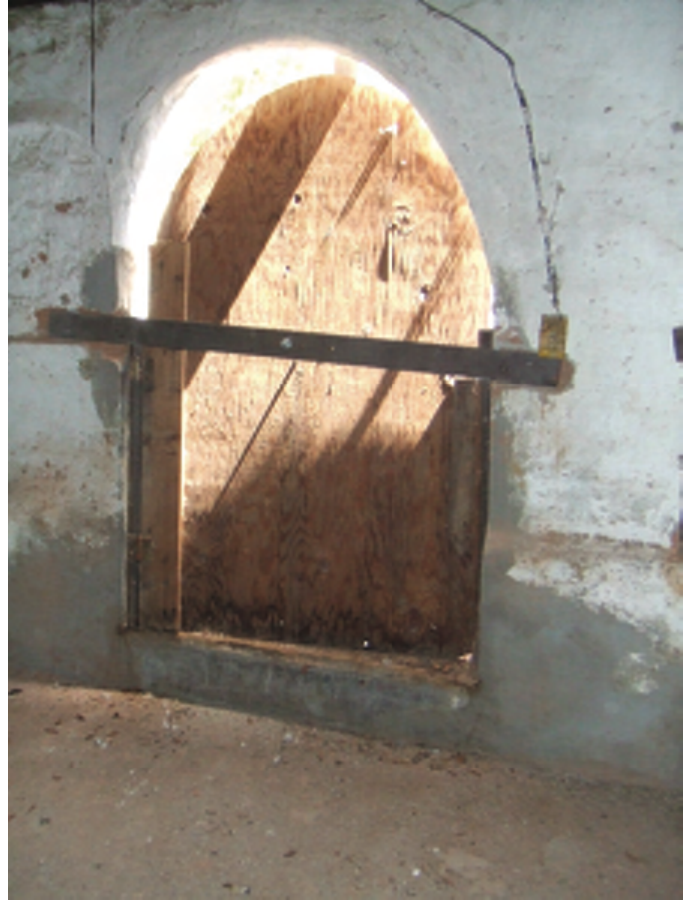
Arched opening at southeastern room

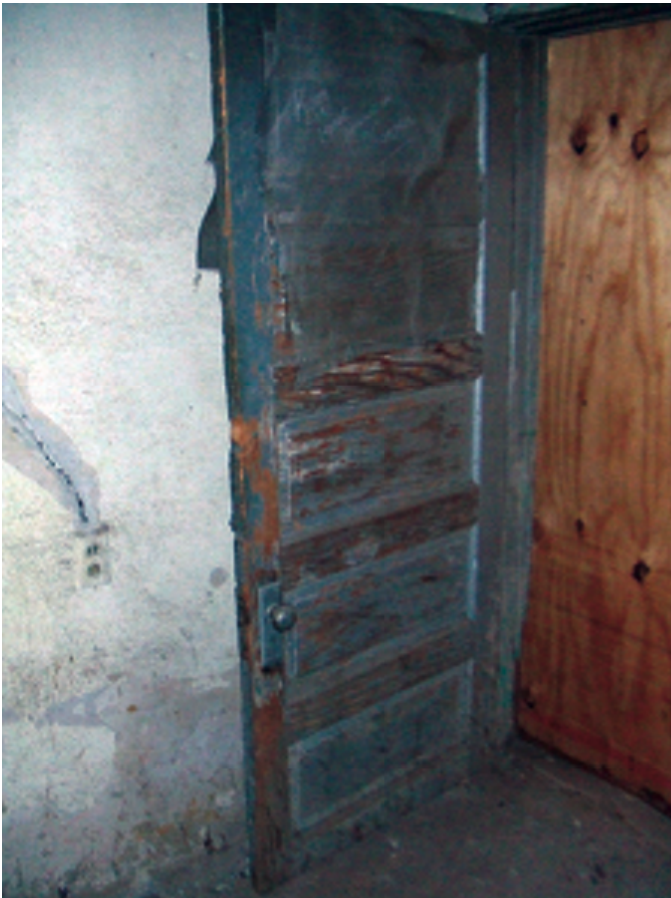
Windows and doors are in very poor condition. Most of the window sashes have been removed and are in-filled with plywood coverings. Exterior door are also in poor condition and will require significant repairs to be operable. Interior wood doors range from fair to poor condition. Several three-panel wood doors are still present and appear to be repairable.

Exterior wood door at north-central room

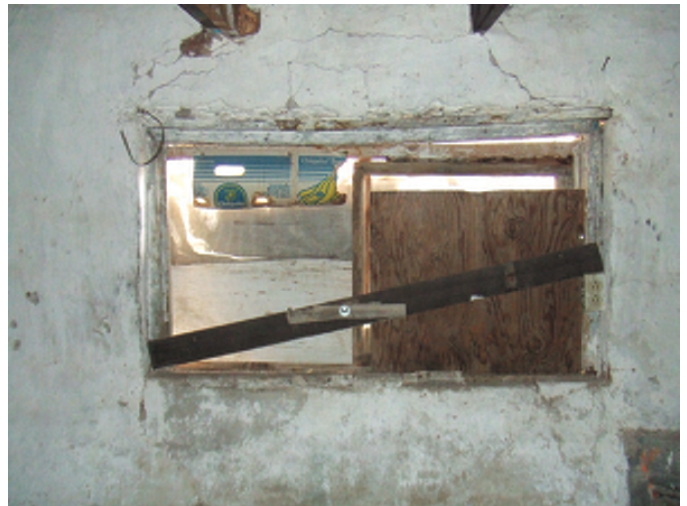
Wood framed window opening at southwest room.

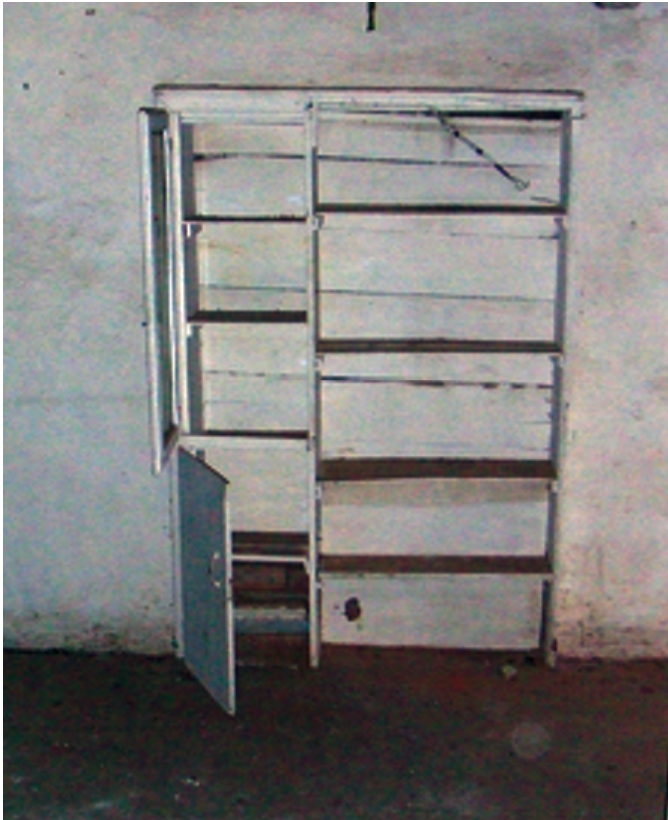
Built-in wood cabinet in the kitchen

Interior built-ins consist of a variety of wall niches, a built-in cabinet in the kitchen and the cobblestone fireplace in the southwest room. These unique elements add a great deal of character to this space, even in its current poor condition. These accents should be preserved and additional research should be compiled to understand their history and how they were used, including any ceremonial uses.

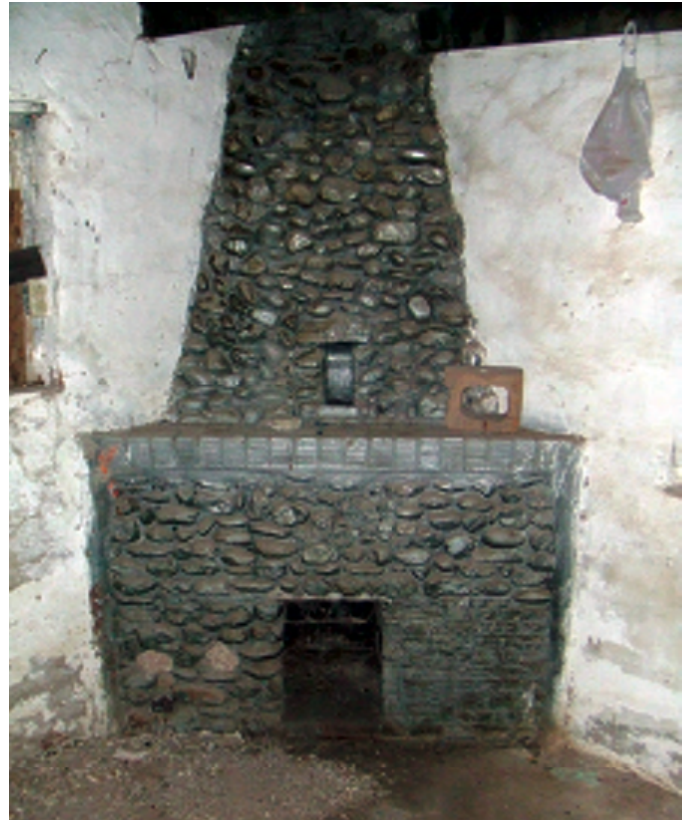
Cobblestone fireplace in the southwest room
