HISTORIC LANDMARK SIGN (HLS) TREATMENT PLAN

Designed and fabricated by Hearn Sign Co in 1954, the Hirsh's Shoes eligible Historic Landmark Sign is a roof mounted letter form sign located at 2934 East Broadway Boulevard. The individual letters spelling HIRSH'S are faced with double neon letter forms and SHOES faced with a single neon letter form.

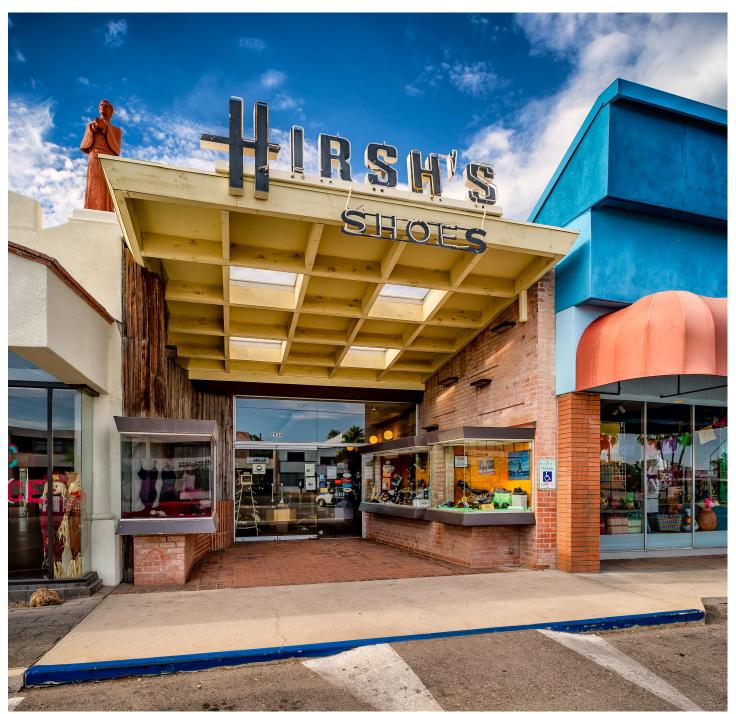
Hirsh's Shoes building and roof mounted neon sign. 2012

The simple Hirsh's Shoes design embodies classic 1950s industrial motif and contains flat double and single-tube block letter script. The cabinet construction of the word HIRSH'S with a folded edge is typical of the classic HLS sign era.

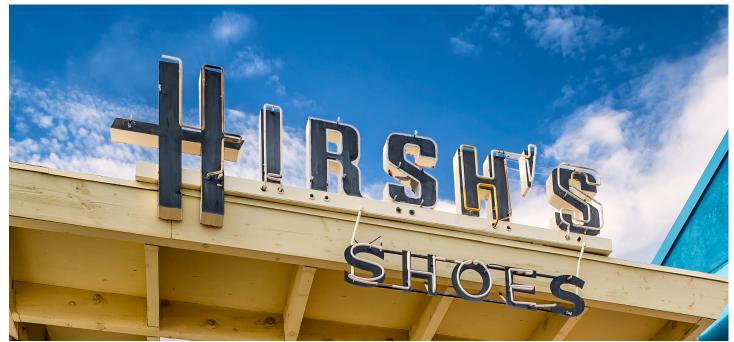
Hirsh's Shoes Neon Sign, pre-restoration, 2012

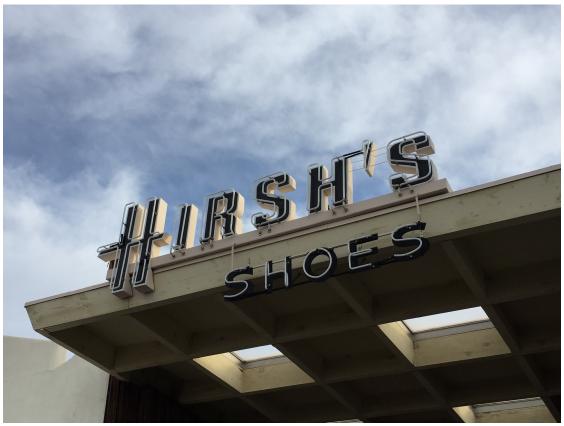
Hirsh's Shoes Neon Sign, pre-restoration, 2016

The eligible historic landmark sign was fully restored in the 2012 to a fully operational base line. It is currently installed and operable. The sign was inspected in fall 2016. The sign shows no sings of weakness or rust. The angle iron is joined together by welded joints all of which are intact and show no sign of weakness, loss or substantial rust. All weld-points are solid and intact.

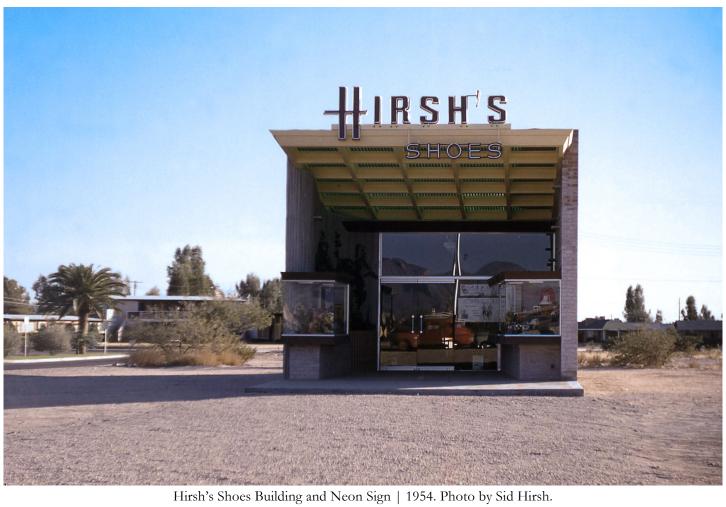
Photograph shows the original color scheme, height and placement of the sign. Additionally there are surviving permit records that details the original installation of the sign

Hirsh's Shoes Building and Sign | Photo by Ray Manley | 1956

The sign retained physical evidence of it's original colors neon glass that allowed for the restoration of the original design intent in 2012. The technique of the Hirsh's Shoes sign construction – sheet metal cabinet and neon mounted to a roof edge is representative of the Classic Landmark Sign era.
